# A Quick-Action Emergency Repair Kit

# 1000 Series BELZONA 1212 LEAK SEALING KIT

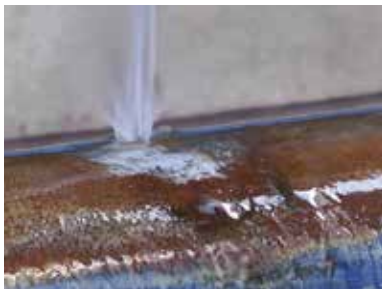
Pipe leak

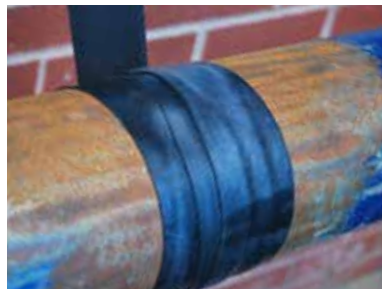
Belzona 9611 and tourniquet

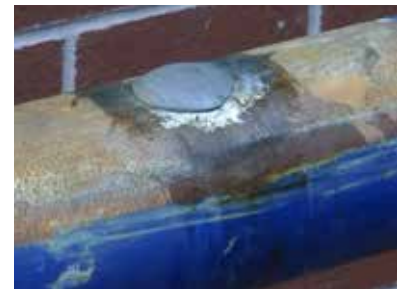
Belzona 9611 stops the leak

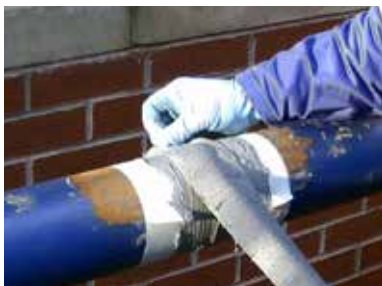
Belzona 9341 applied to perform a wrap repair

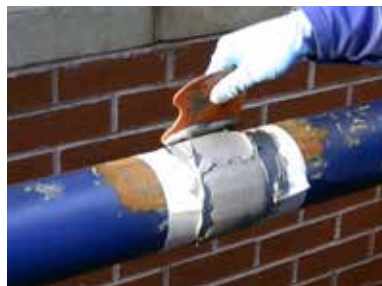
Belzona layer of Belzona 1212 applied

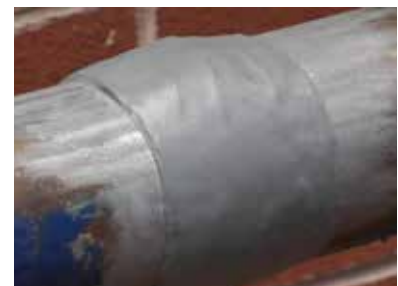
Leak repair completed
